Dealer Support Documentation

SmartRock 2 Sensors

The goal of this document is to provide additional guidelines to Giatec's dealers to empower them to act as the first layer of support in a situation where customers are facing some issues with the SmartRock 2 sensors, the phone application, and the Giatec 360 platform. In this case, the dealer can refer to this document and follow some troubleshooting steps that will either resolve the issue or will provide necessary information for the Giatec Support Team to help solve the issue more efficiently. The dealers are involved in Tier 1 support, the Giatec Support Team will handle cases that escalate to Tier 2 or 3.

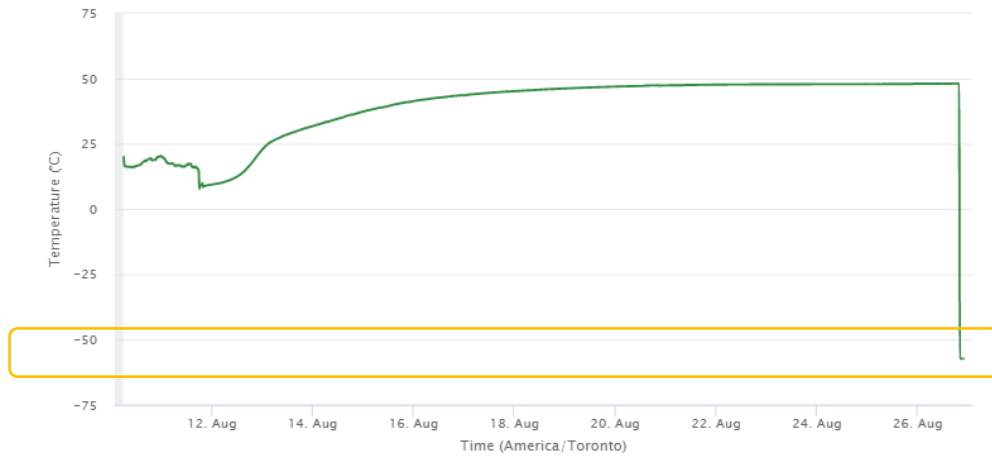
B.1 Extreme low temperature profile

The sensor reads a consistent temperature that is extremely low in the 40°C (-40 °F) range. This indicates a fully cut cable.

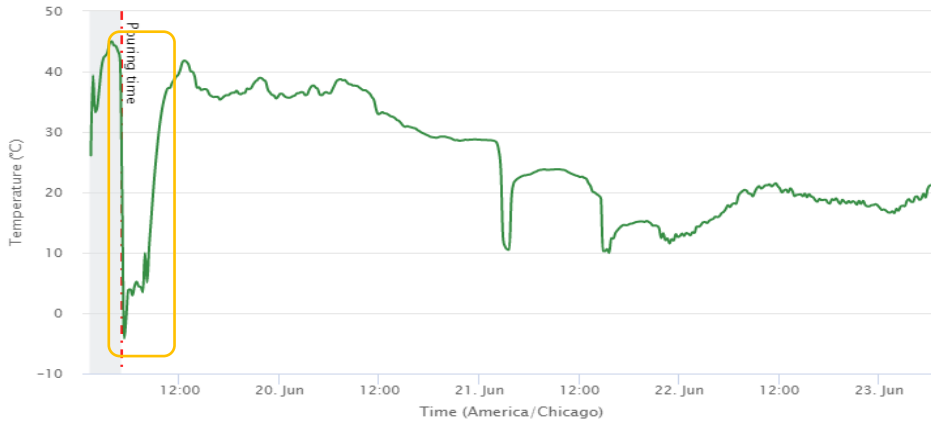
B.3 Low temperature profile

The sensor shows low temperatures that would be abnormal for the time of year and location. The low temperature behavior occurs in the first couple of hours after the concrete pour.

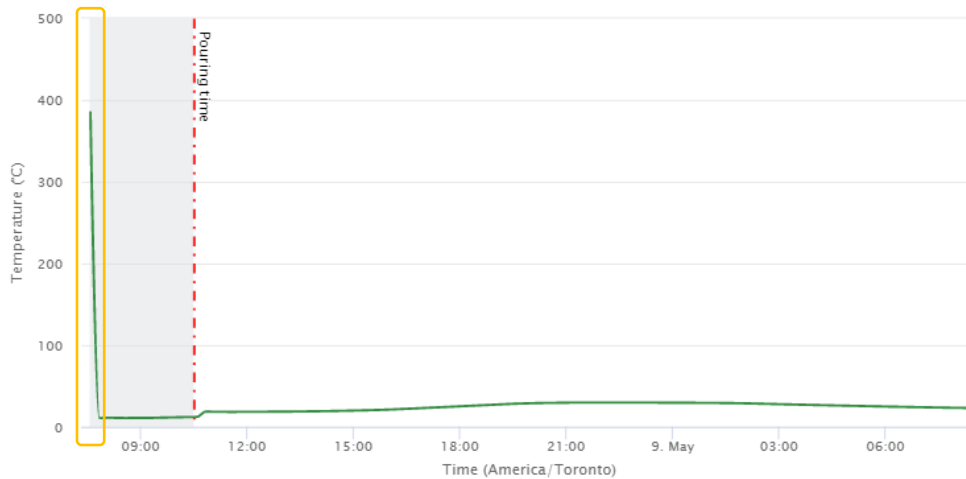
B.4 Temperature profiles- abnormal first temperature point

The sensor only shows the first temperature measurement to be off (usually 385 °C (725°F)), all subsequent points appear to be within range.

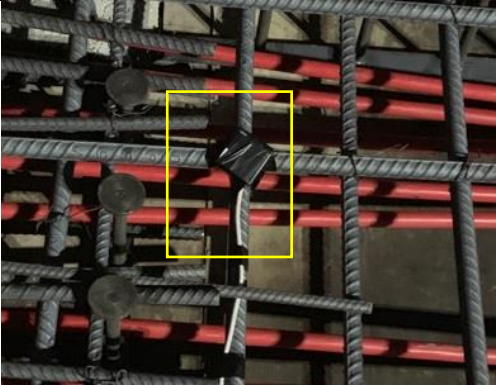
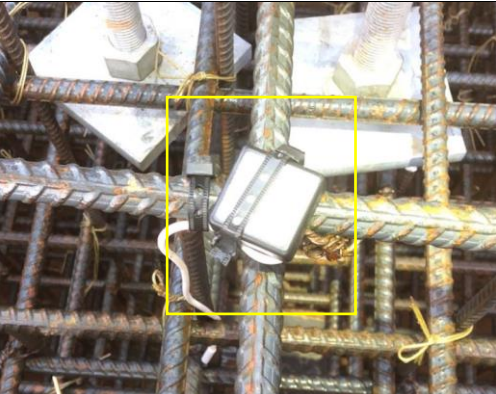
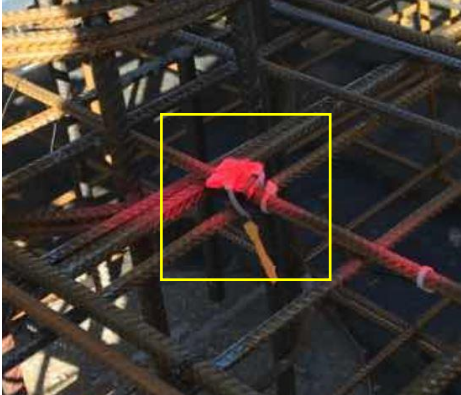
The black box must have the white label facing up and must be installed at a maximum of 5cm (2in) below the concrete surface to obtain Bluetooth signal outside the concrete. The Bluetooth signal comes out of the white label; if the sensor is placed with the label facing the opposite way this considerably reduces the Bluetooth signal range and will most likely prevent connection to the sensor.

<p><i>Black box secured at an intersection with tape to prevent rotation, label is facing towards the concrete surface.</i></p>	<p><i>Sensor rotated almost 180°, label is not facing toward the concrete surface. Sensor is not properly secured to the reinforcement.</i></p>

<p><i>Black box secured at an intersection with a zip tie to prevent rotation, label is facing towards the concrete surface.</i></p>	<p><i>Sensor is installed upside down, where the label is not facing the surface of the concrete.</i></p>

<p><i>Sensor properly secured to reinforcement using zip ties. The sensor is also clearly indicated which will prevent workers from stepping on it prior to the pour. Sensor installed with the label facing the concrete surface.</i></p>	<p><i>Sensor rotated by 90° in a position where the label is not facing the surface of the concrete. The sensor is not properly secured to the reinforcement.</i></p>

Securing the sensor on the second layer of rebar is a very common practice among the customers to reduce the risk of damage or rotation of the sensor if stepped on; but make sure that the barcode is facing away from the adjacent rebar. If the sensor is facing and touching the top layer rebar, there is a chance that the majority of the Bluetooth signal is absorbed into the rebar (Appendix A.1 and Appendix C).

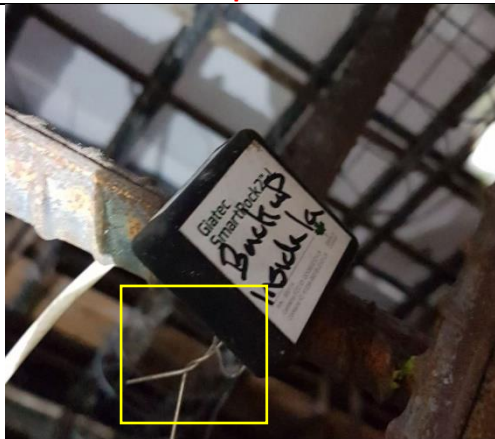
Bad practice

Only a few twists along the length of the wire were done. The twisting is loose and upon movement can be prone to cause disconnection of the wires, deactivating the sensor. No additional blue connectors or tape is provided.

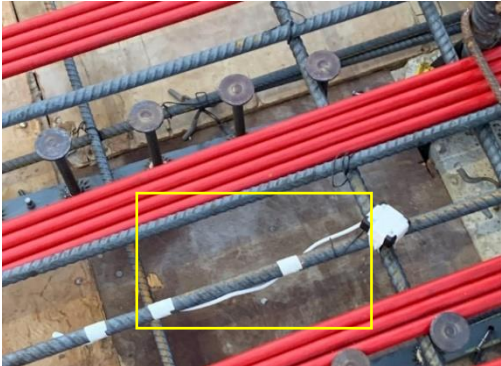
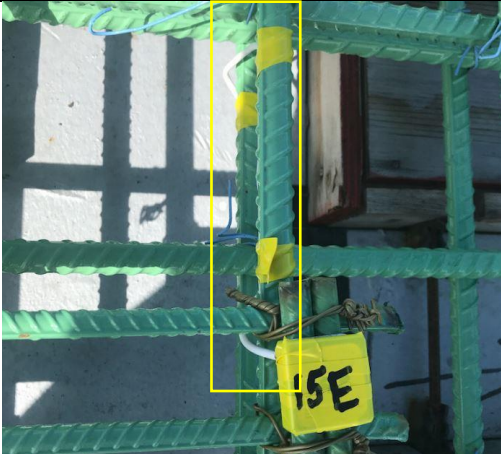
<p>Temperature cable must be secured to the rebar. Loose or unsupported cables are prone to damage during the concrete placement (pumping, vibration, and traffic). Metal ties shouldn't be used for securing the cables, metal ties tend to be overtight and damage the temperature cable.</p>	
<p>Good practice</p>	<p>Bad practice</p>

<p><i>Cable well secured below the rebar (for protection) and attached with tape to prevent movement.</i></p>	<p><i>Cable not secured and prone to movement and damage during the concrete pour.</i></p>

<p><i>Cable well secured below the second layer of rebar (for protection) and attached with tape to prevent movement.</i></p>	<p><i>Cable is unsupported on its length and secured with metal tie wires.</i></p>
